**Maryland Historical Trust
State Historic Sites Inventory Form**

Survey No. F-3-163

historic John Derr House

Summary Description

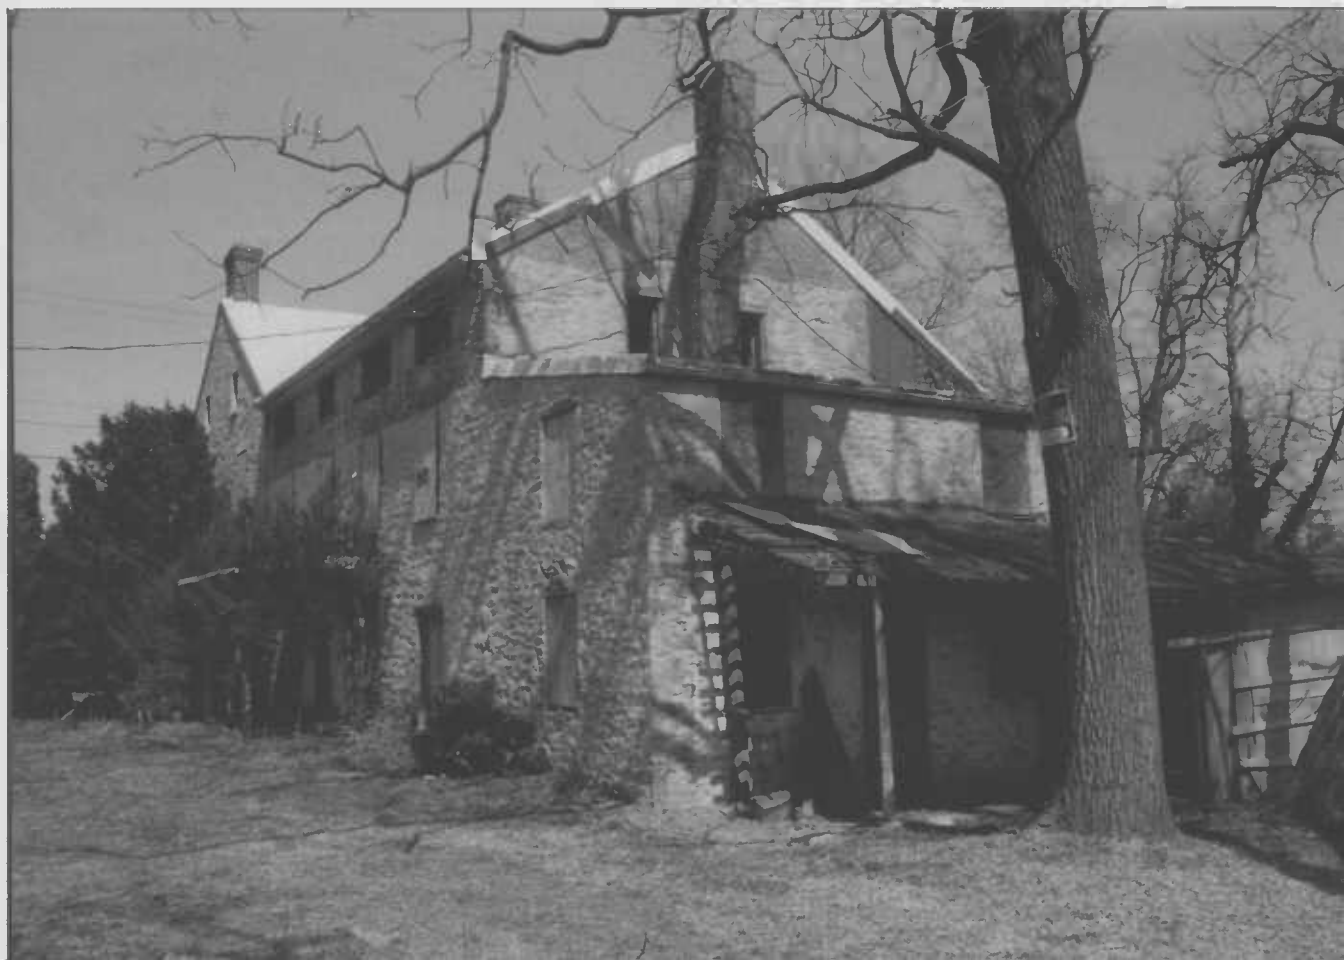
4 of 16

Principal Dwelling, view northeast

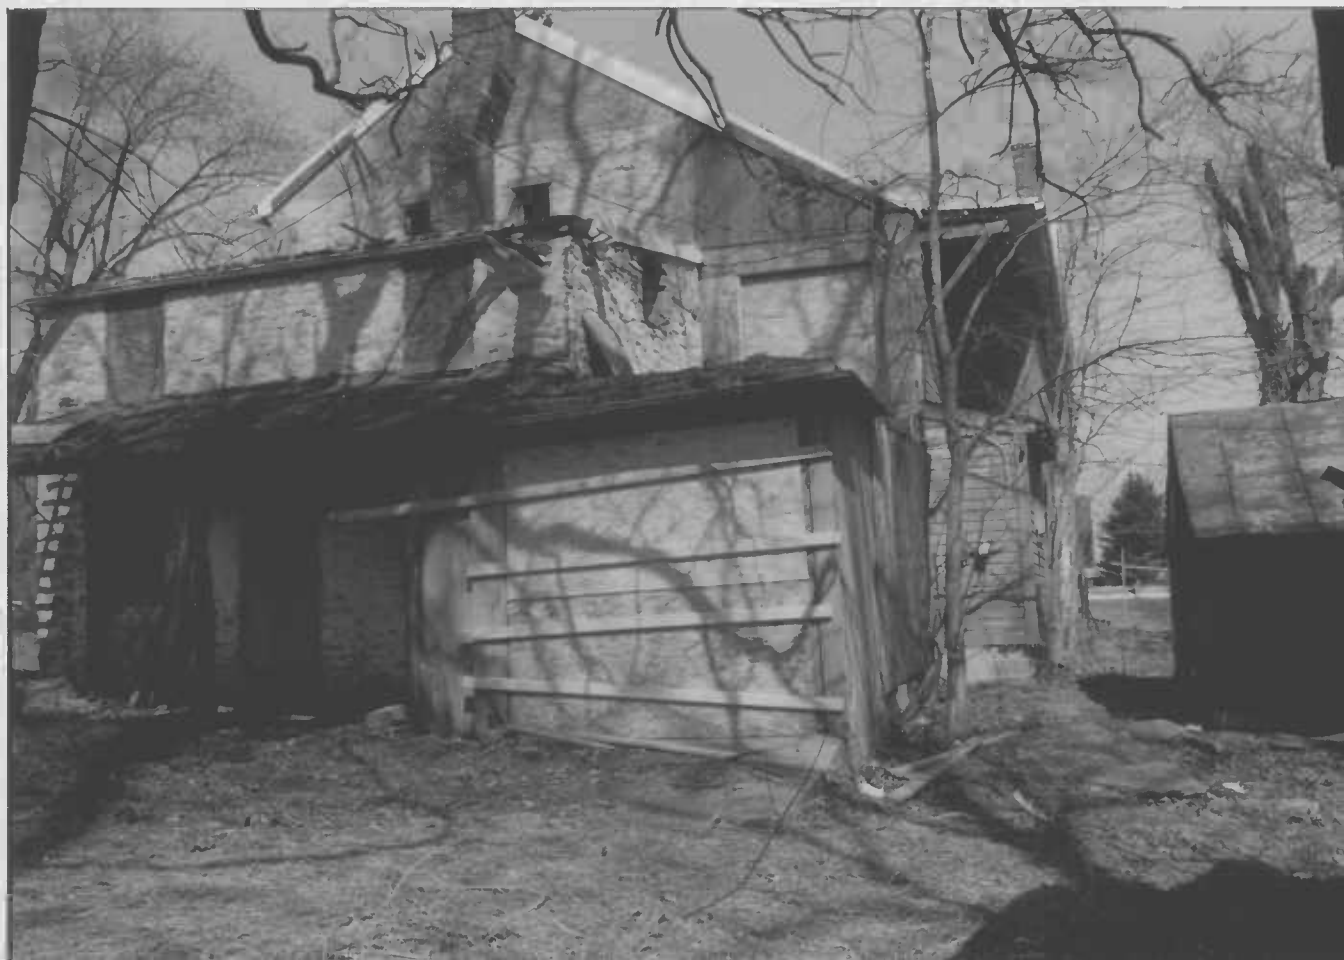
5 of 16

Principal Dwelling, view northwest

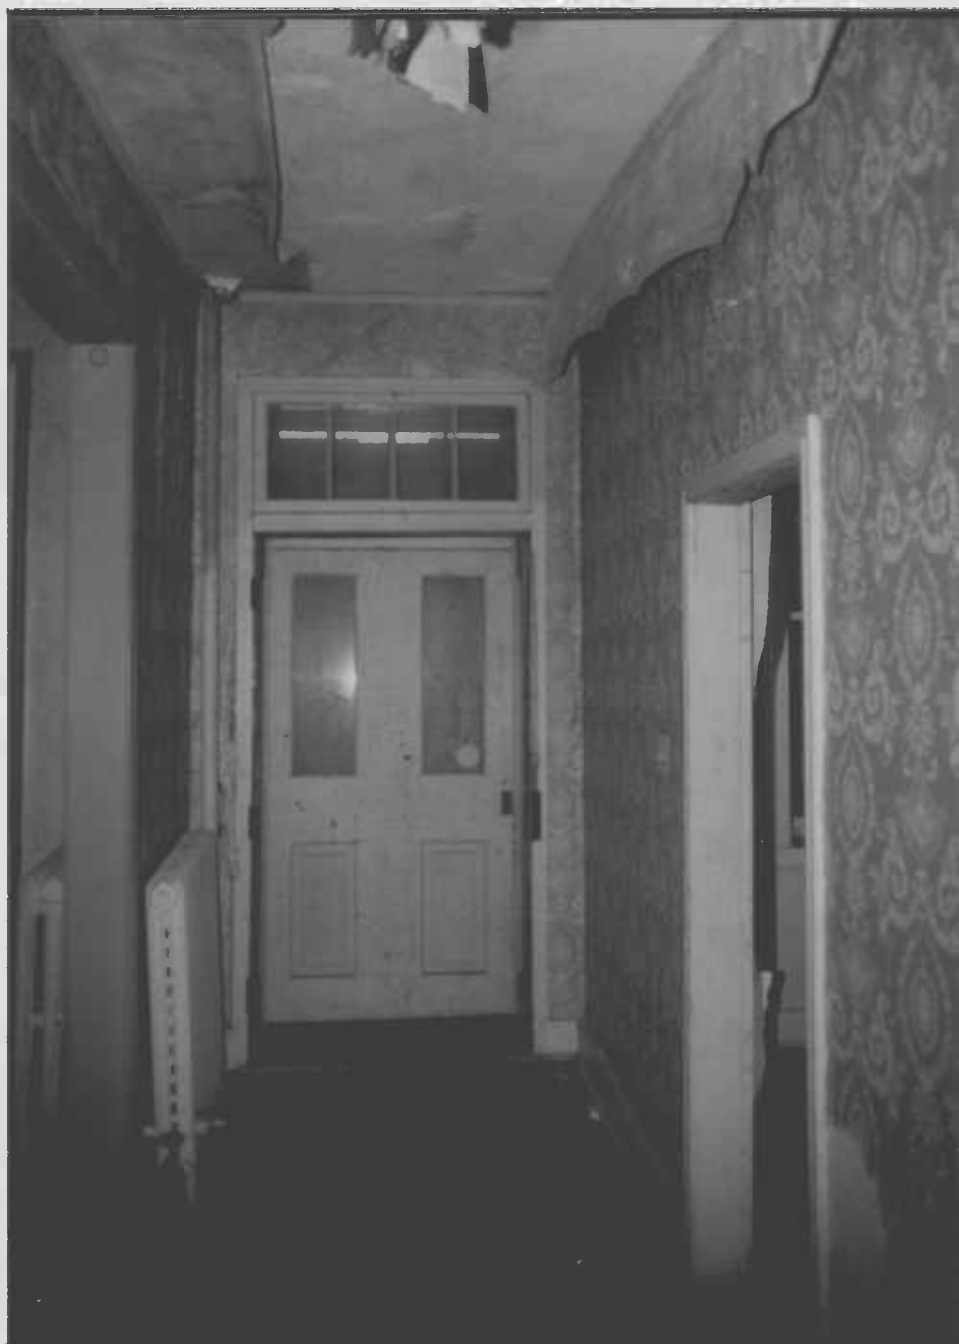
6 of 16

divided into two spaces separated by a modern wood partition wall with a fiber core door surmounted by a plexi-glass transom. The hall contains an open rear stairway with landing that ascends the east, south and west walls. The stairs feature a closed stringer with turned balustrade and newel posts. The balustrade is surmounted by an oval hand rail. The stairway ascends to the second floor and attic. The stairway is a late nineteenth century replacement. The flanking parlors contained central fireplaces with simple wood surrounds and wood mantels comprised of a plain entablatures with shelves. The fireplace surrounds and mantels were modified or replaced during the early nineteenth century. The fireplace surrounds and mantels were removed by vandals in 1999.

Principal Dwelling, first floor, main block, hallway, view north

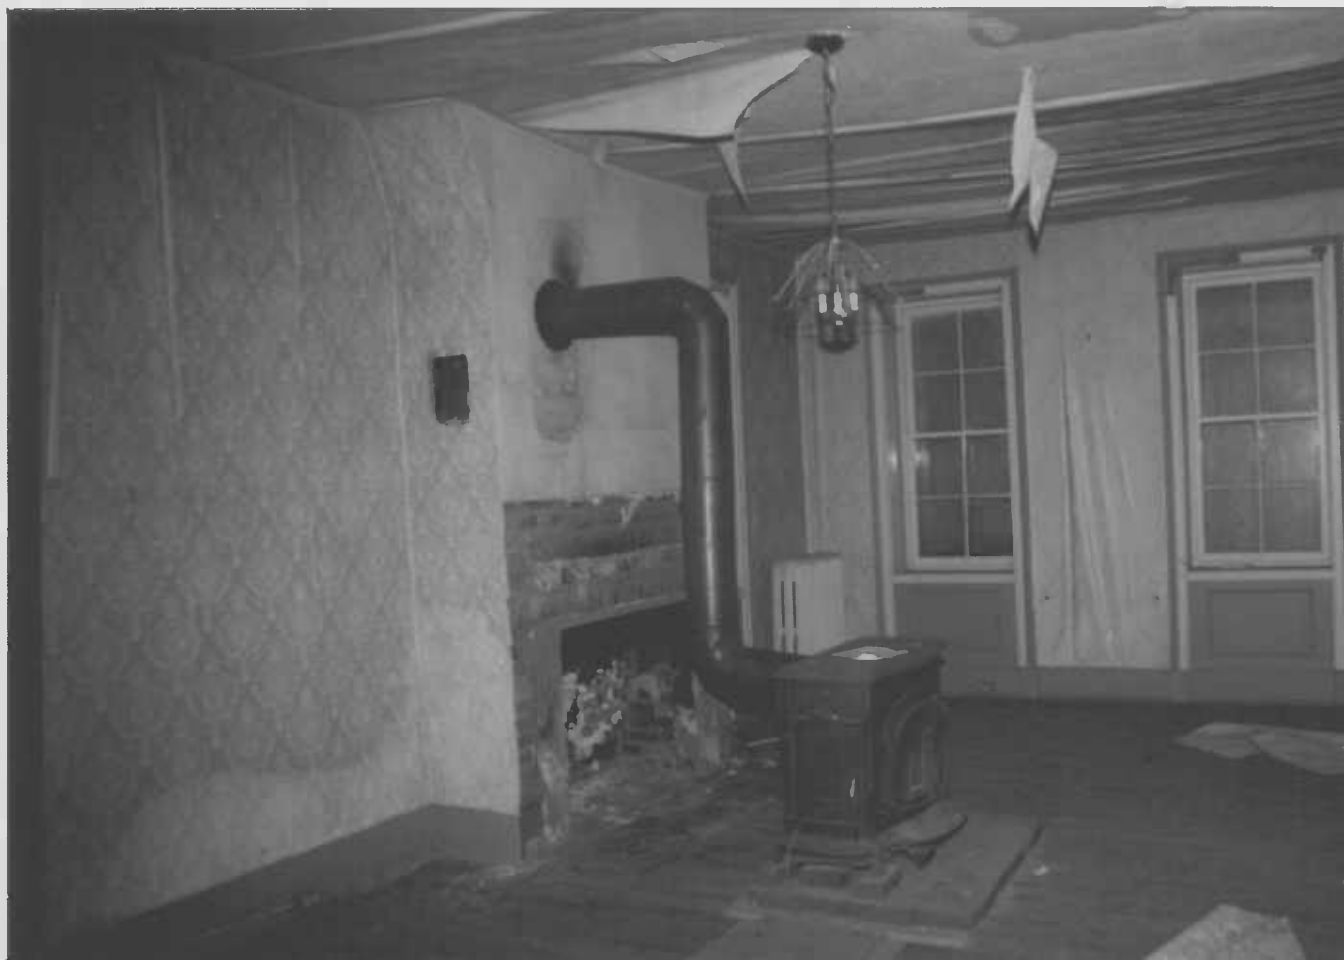
7 of 16

Principal Dwelling, first floor, main block, western parlor, view northwest

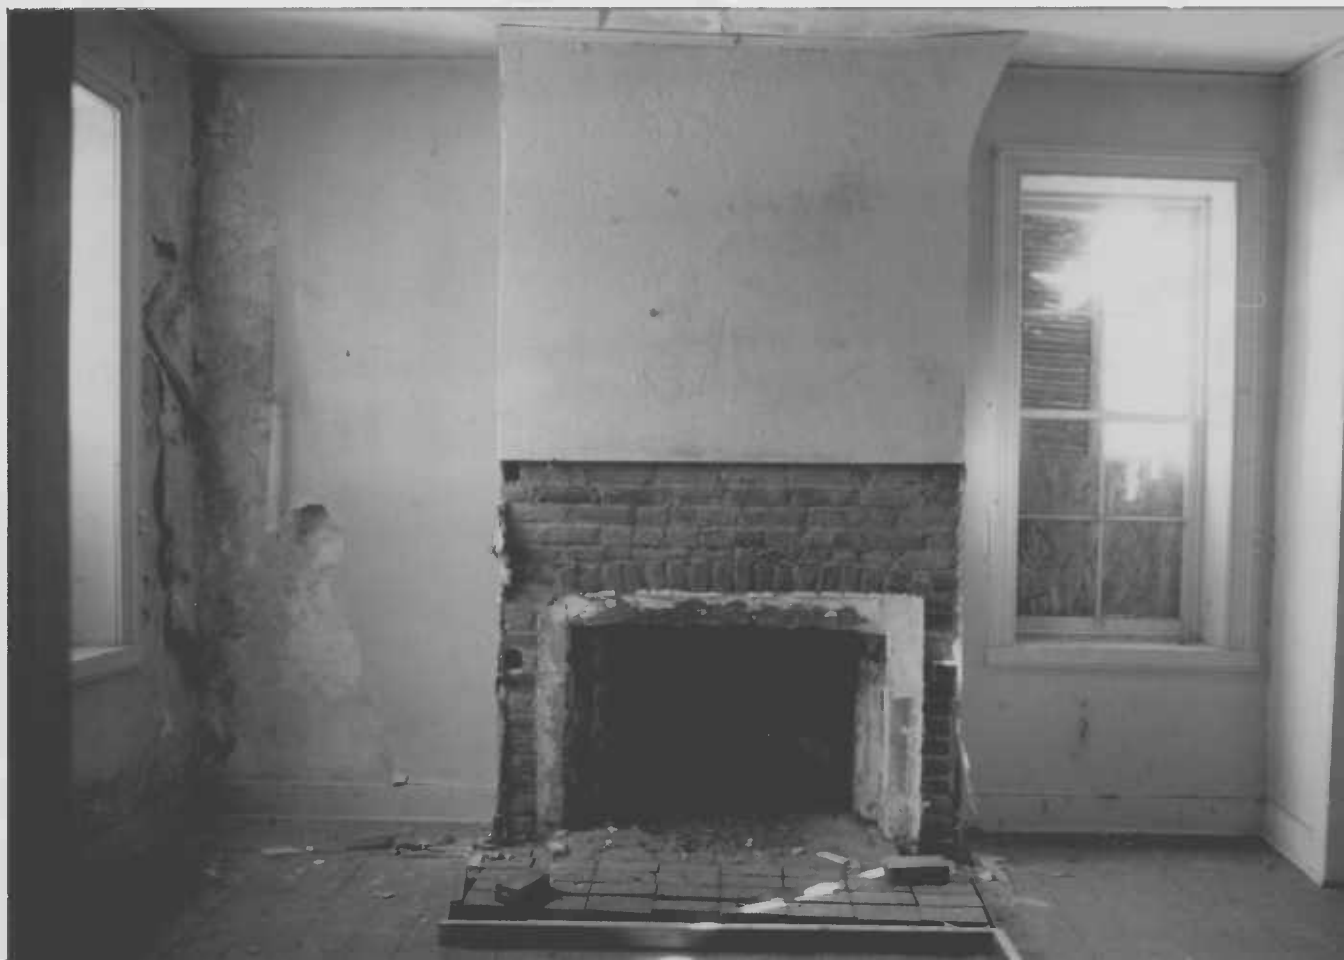
8 of 16

Principal Dwelling, first floor, main block, eastern parlor, view southeast

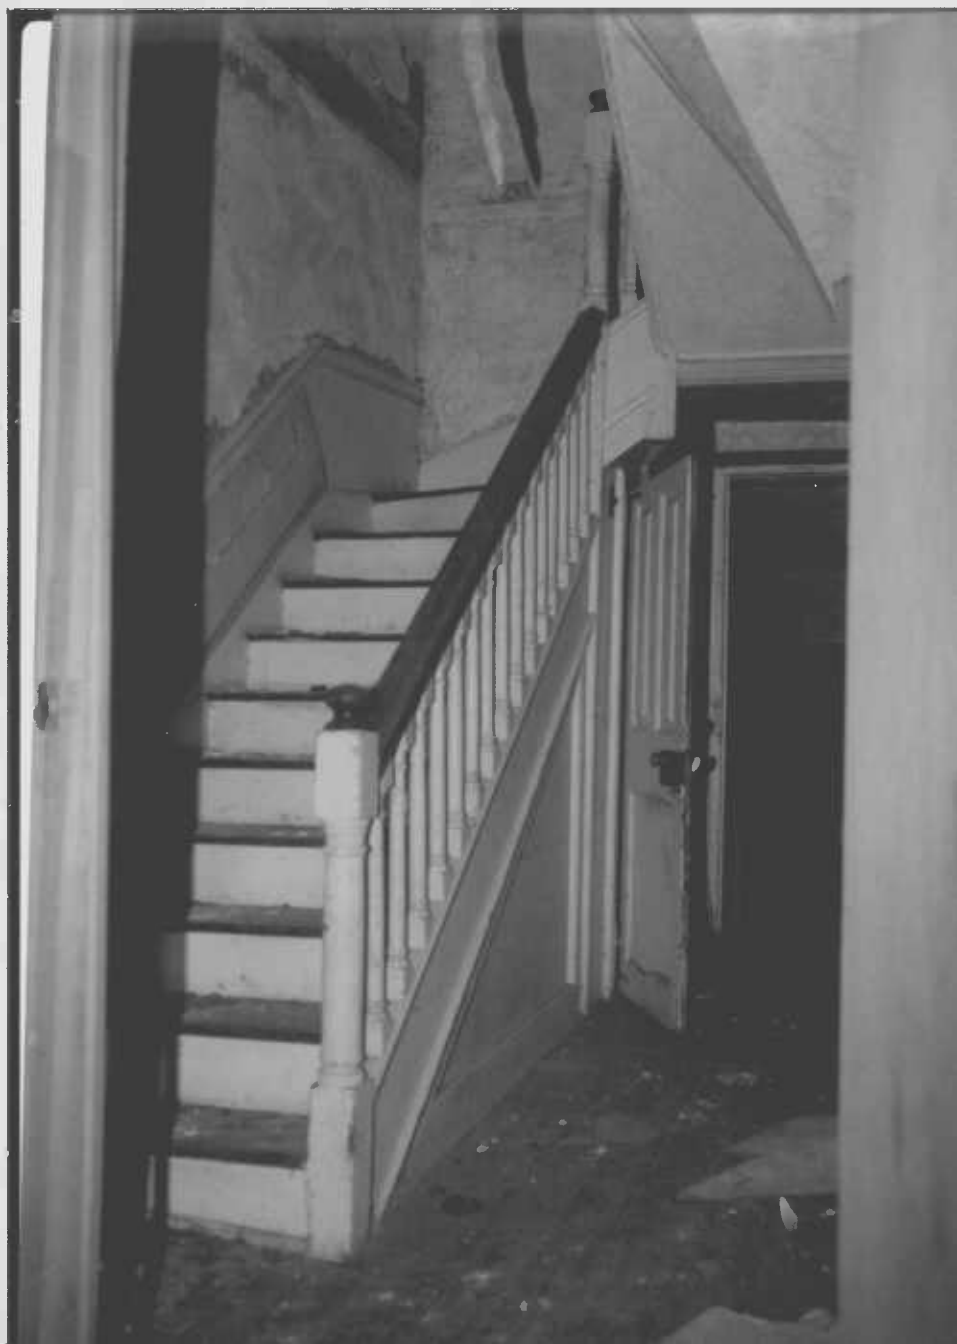
9 of 16

Principal Dwelling, first floor, main block, hall stair, view south

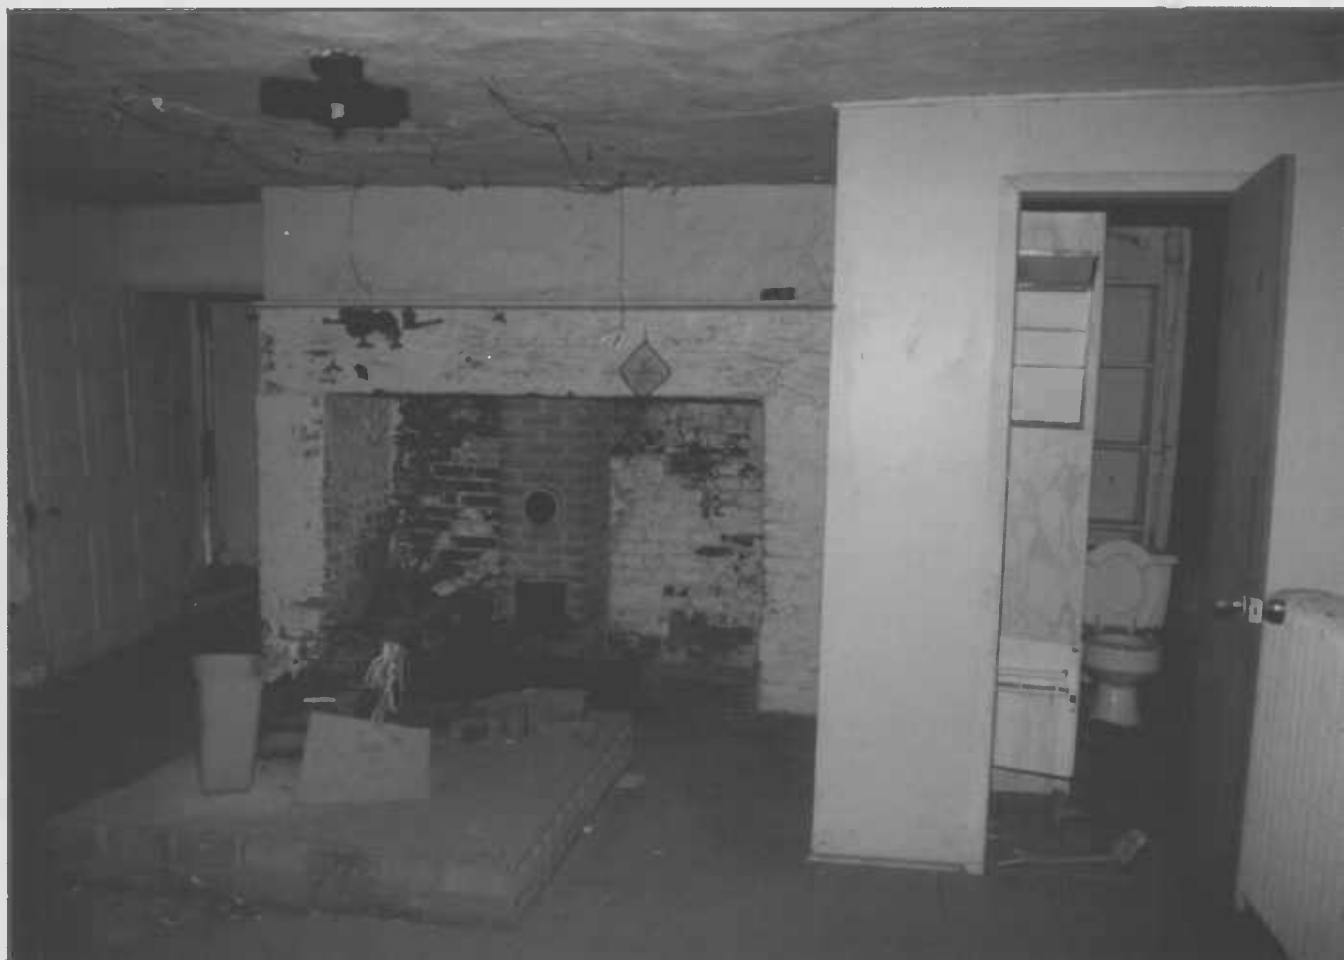
10 of 16

Principal Dwelling, first floor, rear ell, Kitchen hearth, view northwest

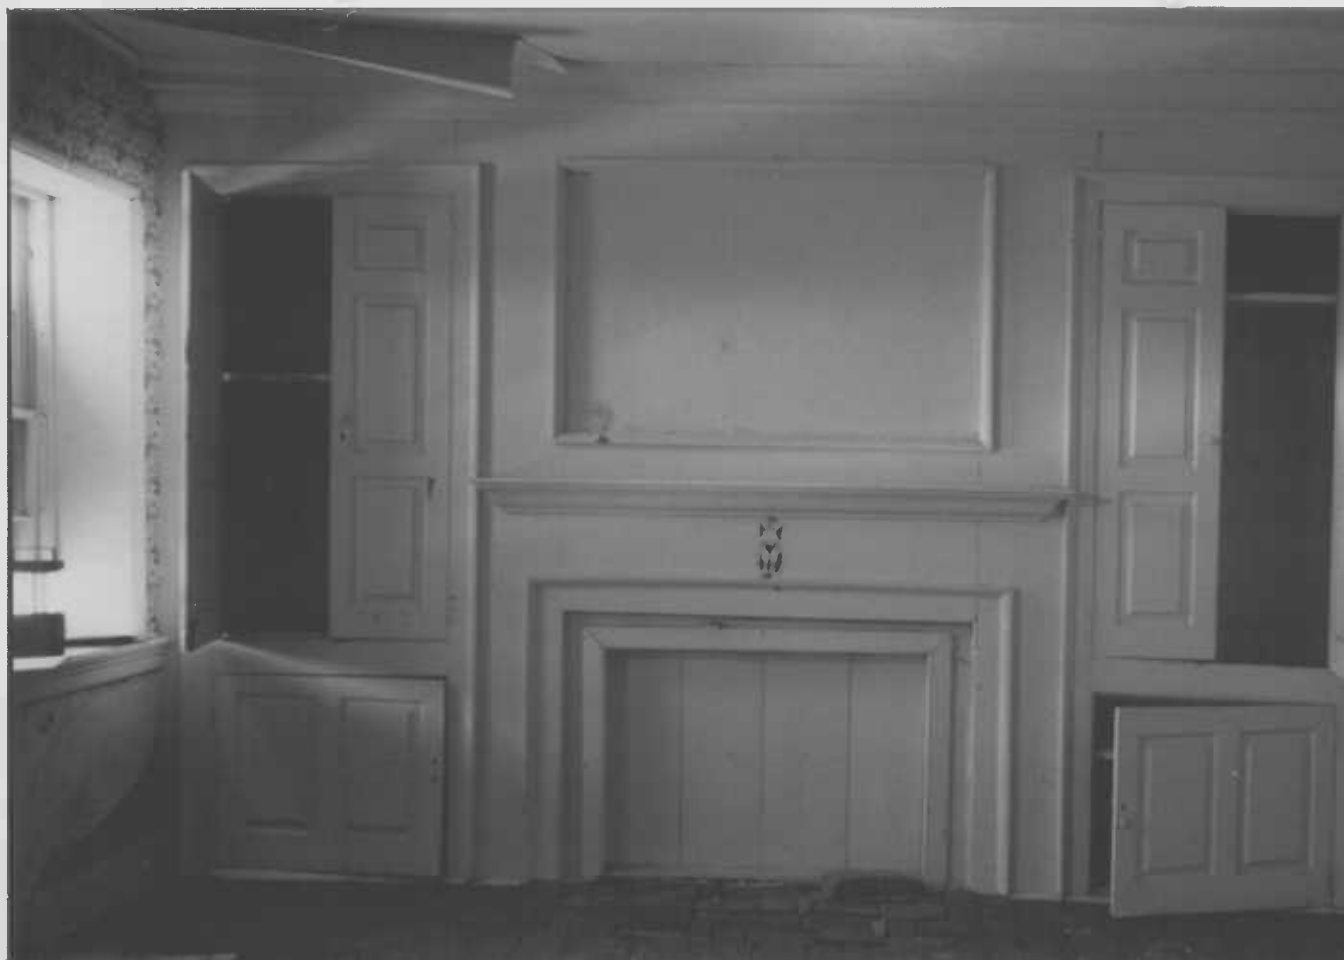
11 of 16

The second floor of the main block was utilized as bed chambers. The floor plan of the second floor reflects that found on the first floor with the exception of the central hallway. All rooms are accessed from the stair landing. The northeast chamber features a central fireplace with wood mantel comprised of a simple entablature and shelf with a paneled wood overmantel with molding. The chimney piece is flanked by built-in wood cabinets with raised panel doors. The massive cabinets, fireplace surround, and overmantel are original late eighteenth-century features of the house. This is the only room that retains its original woodwork.

Principal Dwelling, second floor, main block, eastern bed chamber, view.

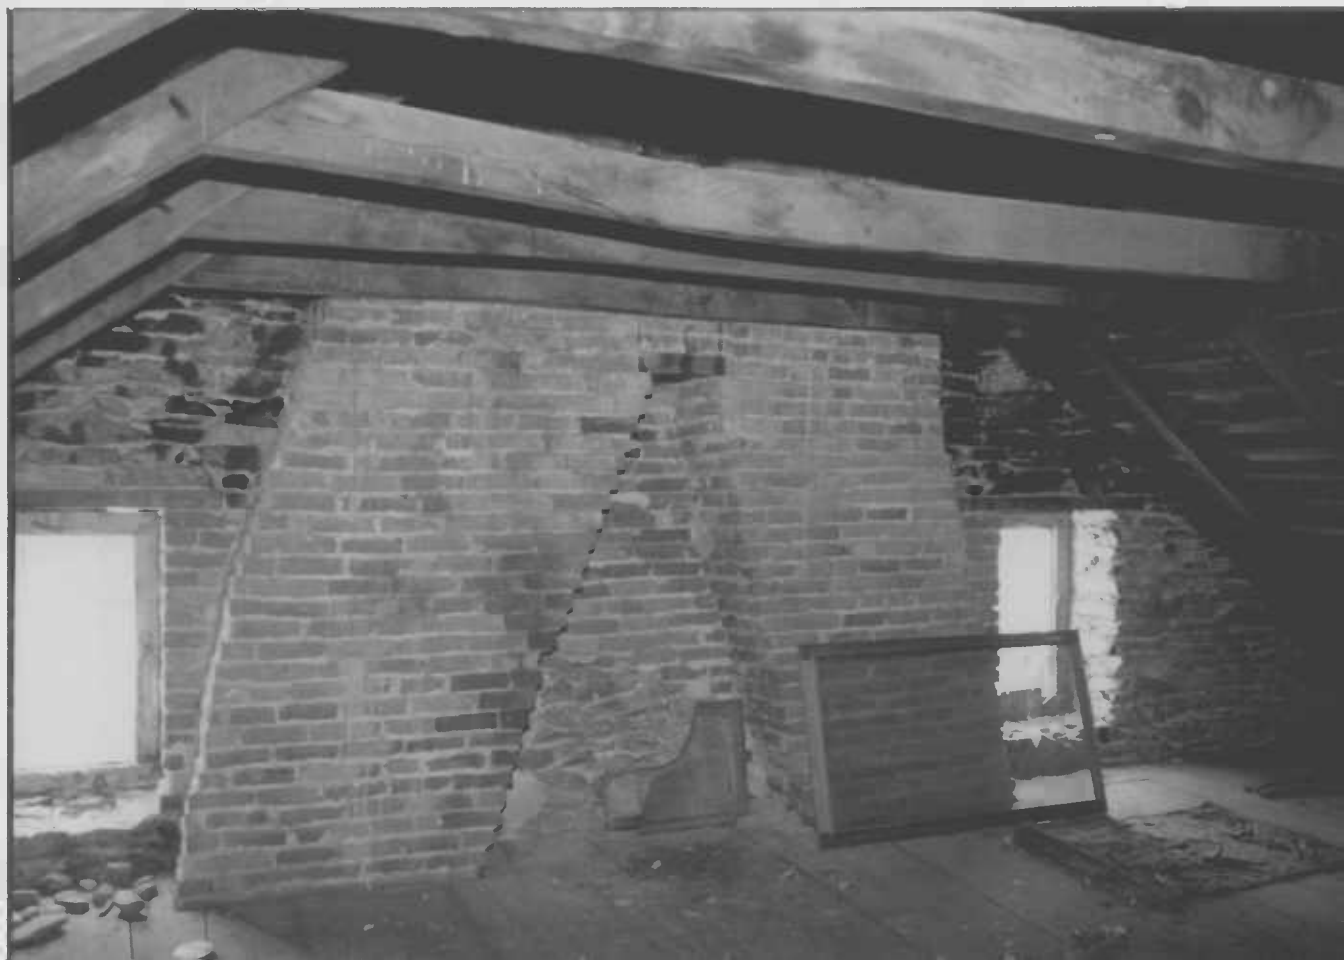
12 of 16

The attic of the main block is accessible from the central stairway. The attic features wide, random-width floor boards. The brick flues of the interior end chimneys rise along the gable end walls. The roofing system consists of hewn rafters, which are lapped and pinned at the ridge line and joined by pinned collar

beams. The rafters are attached to the top plate with a bird's mouth joint. Roof sheathing is secured to regularly spaced horizontal nailers. A layer of wood shingles is attached to the nailers. The exterior face of the shingle roof now is sheathed with standing seam metal.

Principal Dwelling, attic, main block, view west

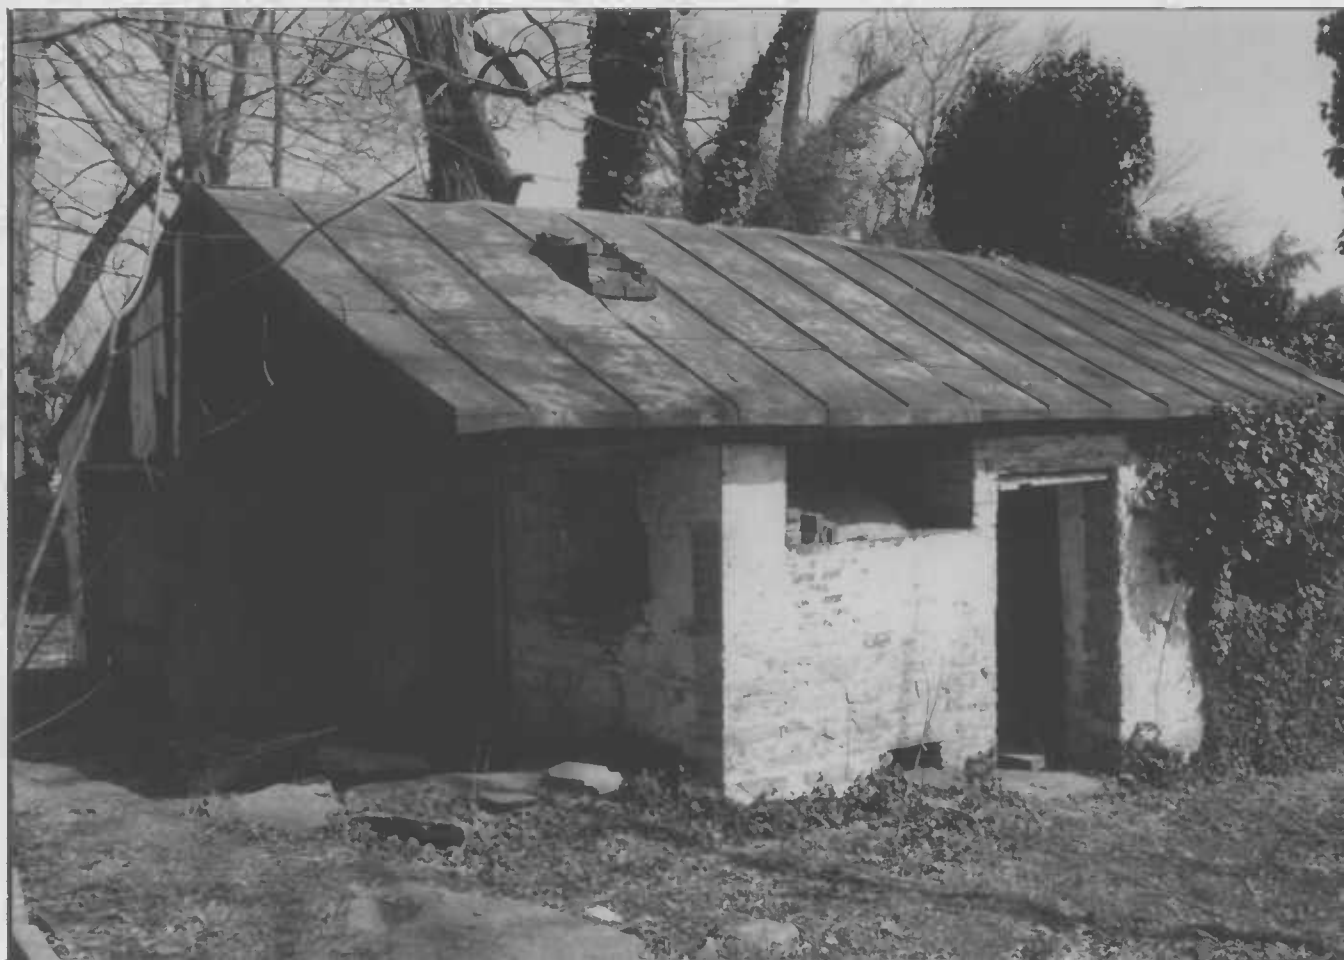
13 of 16

The summer kitchen (ca. 1790-1800) is located to the rear and east of the dwelling. The one-story, one-bay rectangular structure terminates in a side gable roof sheathed with standing seam metal. The structure is divided into three sections composed of beehive oven, drying room and kitchen.

Summer Kitchen, view northeast

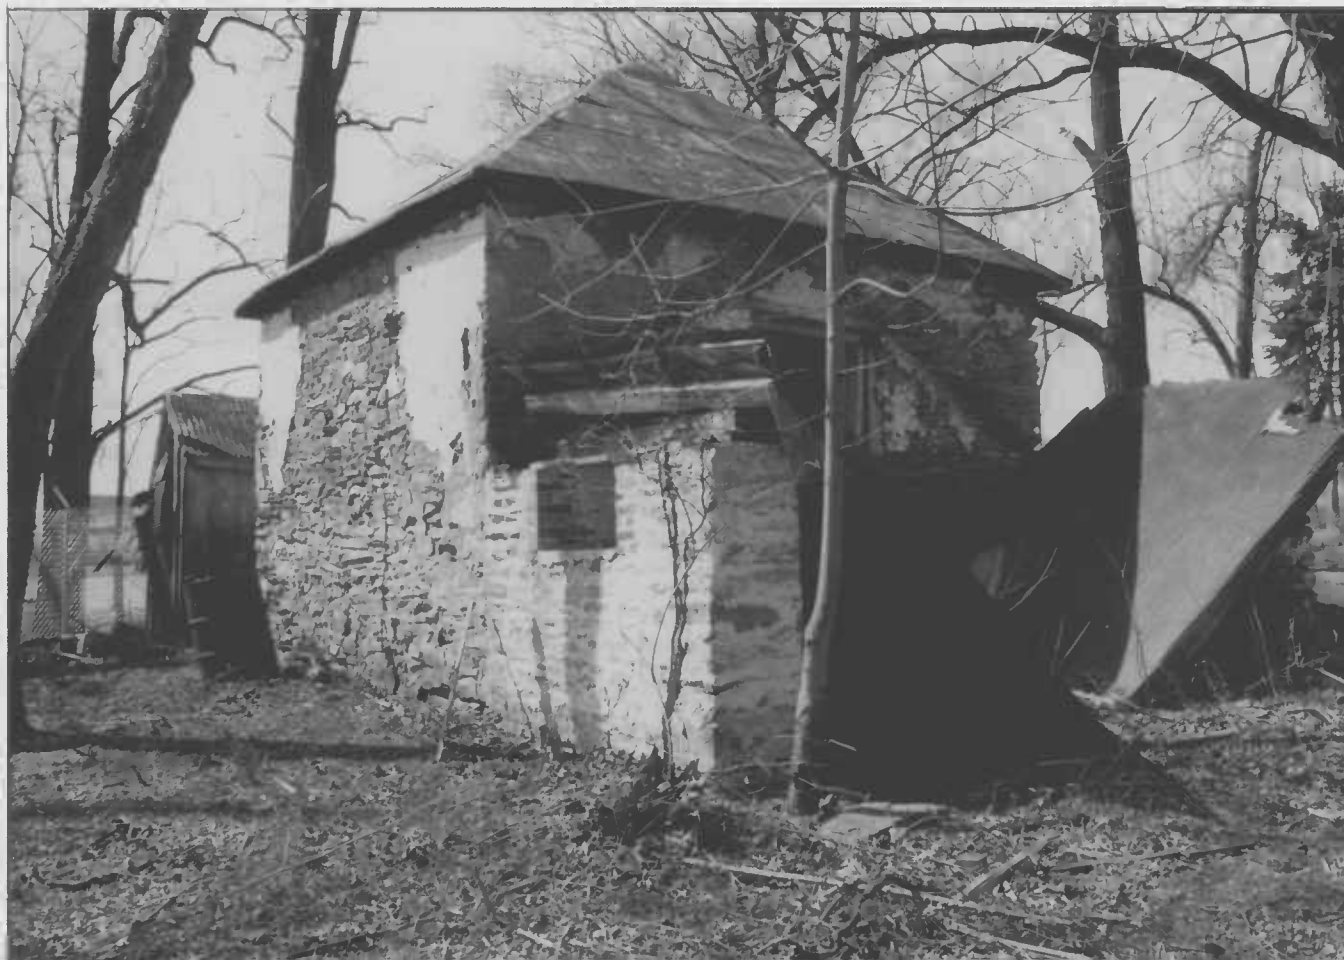
14 of 16

The meat house (ca. 1790-1800) is located southwest of the rear of the principal dwelling. The meat house is a one-story, rectangular-plan structure, built of coursed stone covered with white washed stucco. The structure terminates in a pyramidal metal roof. The structure rests on a raised stone basement. The cold cellar, located in the basement level, is accessed by a central exterior stairway on the primary (north) elevation. The interior of the cold cellar is well insulated. The basement walls are parged
